Confidential
Condition and Value
Report of Marine Survey for the Vessel
Kimberly C
HIN 596518

Vessel: Kimberly C

HIN 596518

Type of Survey : Condition and Value

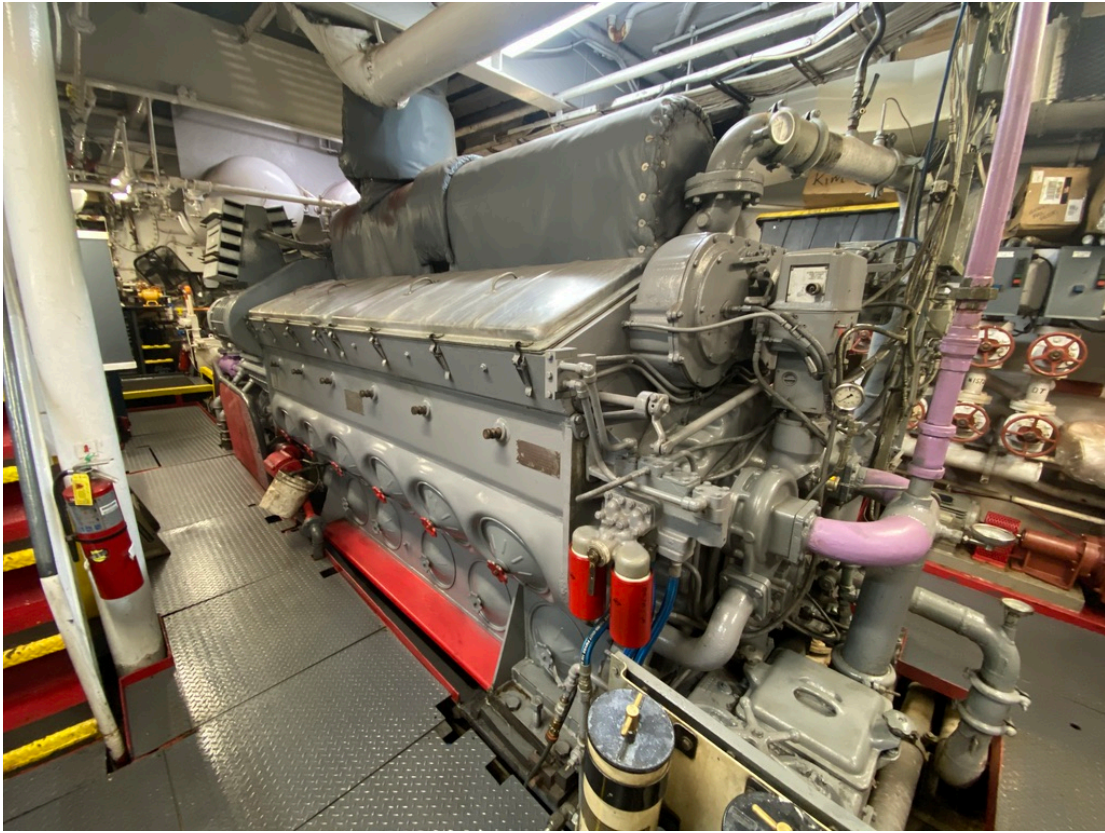
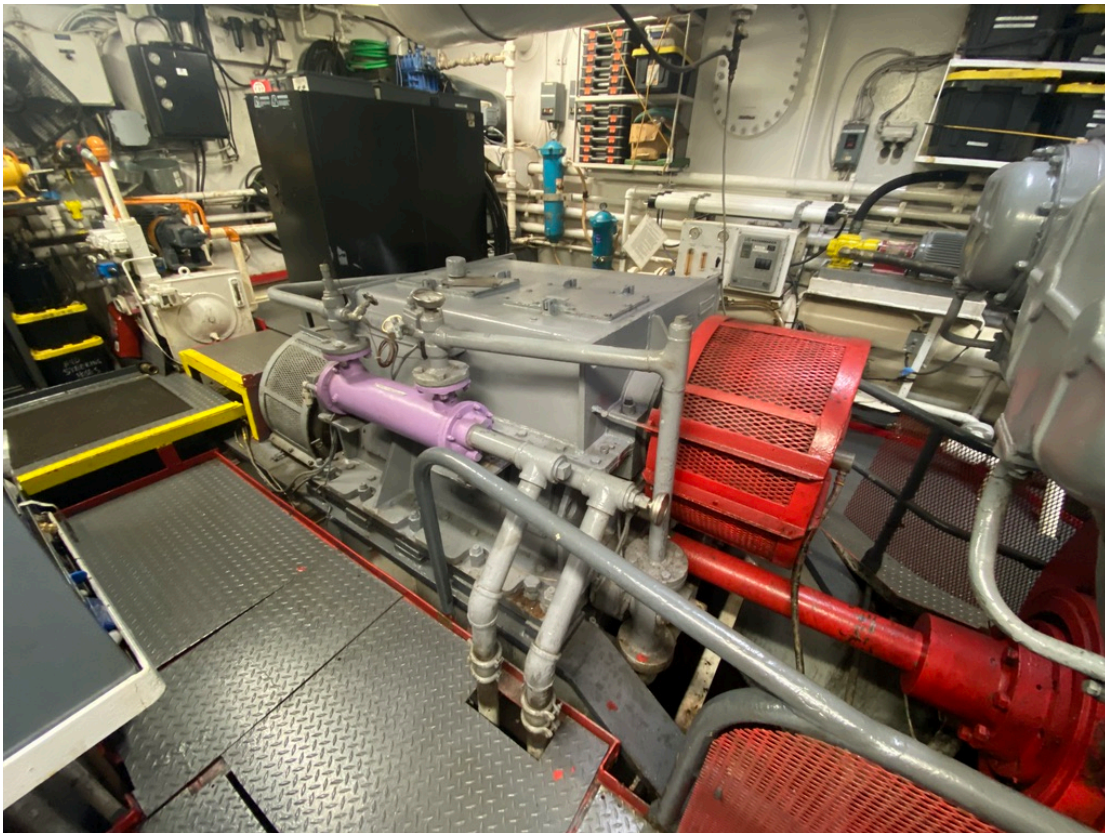
Starboard Main Engine and Gear

(1) **Lufkin Model # RHS2120 Serial # 1260 Max hp 1260** : Inspected and found in serviceable condition

(1) **Detroit Diesel Model # 12-645E2 Serial # 74-F1-1073 AB-88HS- 52516-** : Inspected and found in serviceable condition
