# SURVEY SUMMARY REPORT

Vessel: Kimberly C

Type of Survey : Hull & Machinery

Date of Survey : 5/27/2023

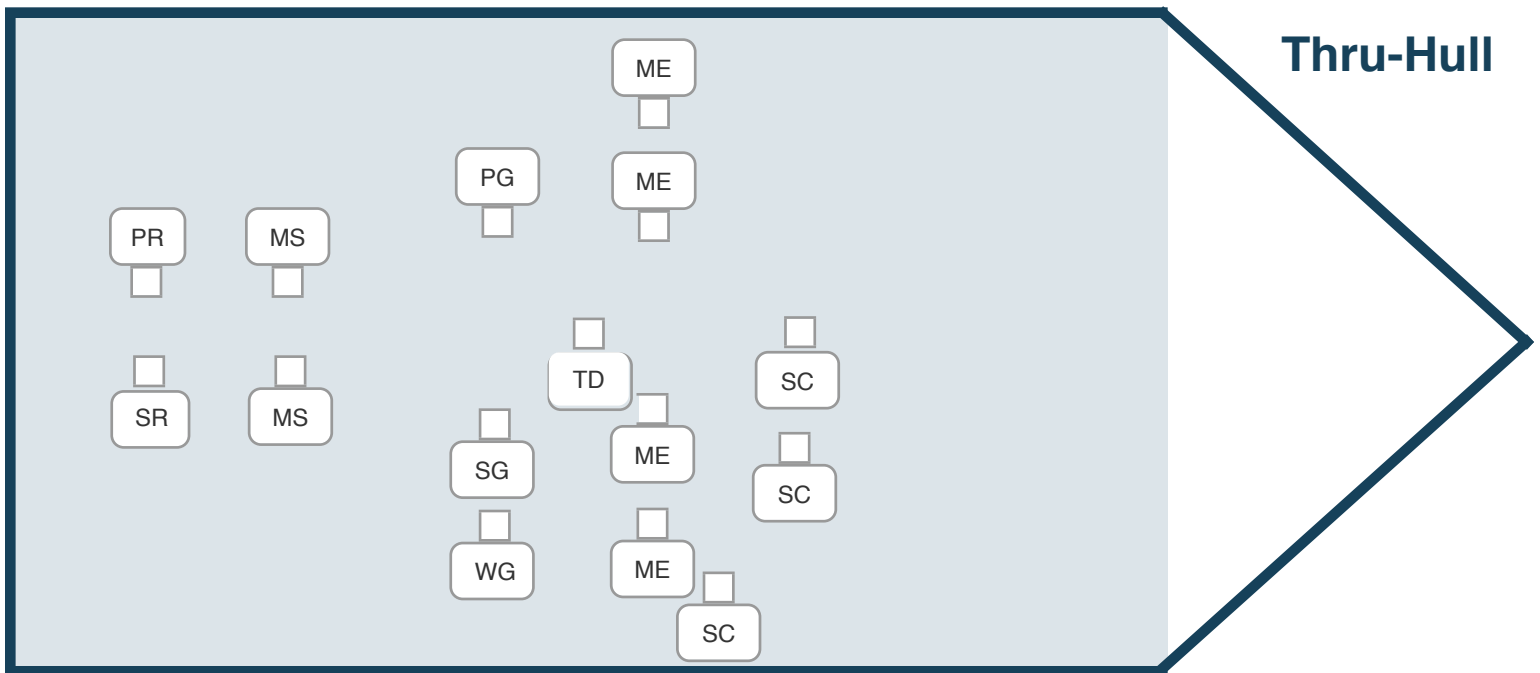
# THRU HULL REPORT

Red X indicates inoperable item.

All thru hull fittings were inspected and found to be in good condition and serviceable. Nothing in this reports relieves the operator of inspecting all thru hull fittings prior to departing and harbor of safe refuge or dockside.
