KIMBERLY C ABS REPAIR ESTIMATE

DATE : 6/18/24

This repair estimate is for items that were called out on the ABS surveyor's report on 3/1/2024. Assumptions have been made for some items based on best marine practices and experience with previous repairs similar to these items. Items requiring gauging of steel thickness will need to be quoted once the gauging and recommended repair plan has been received.

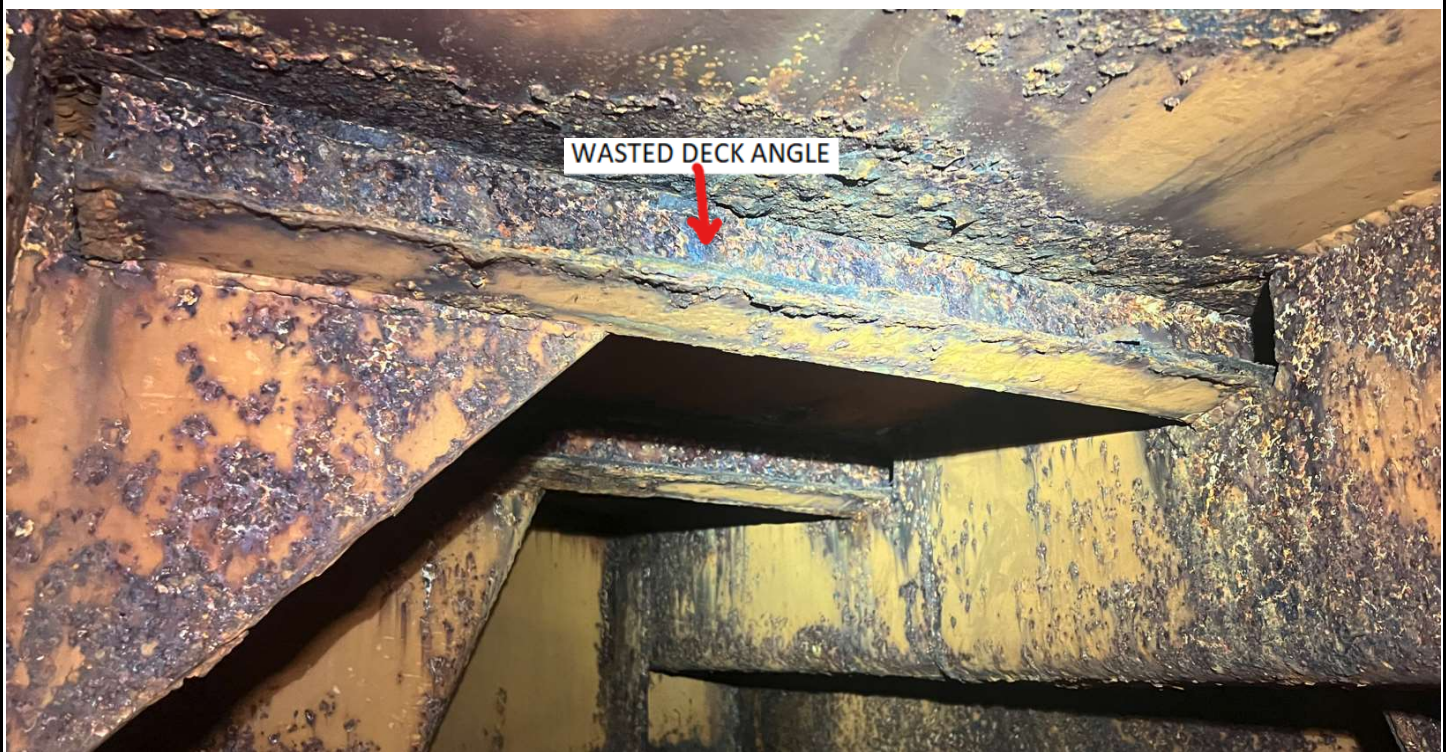
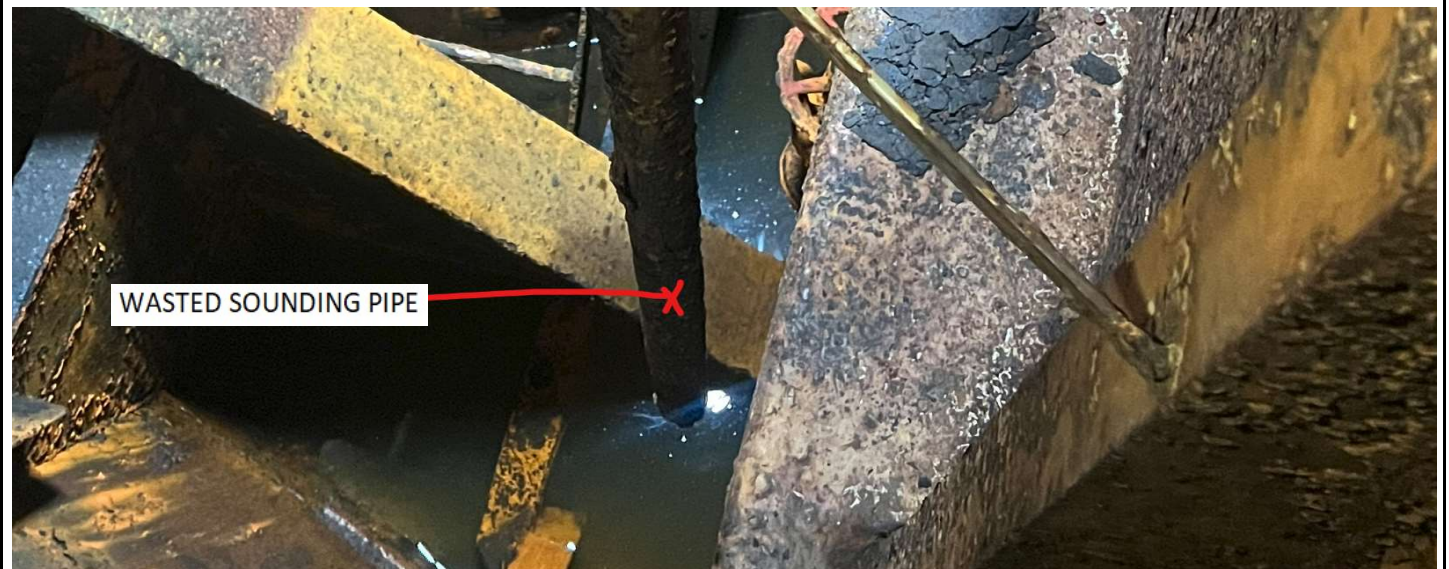
1. FOREPEAK BALLAST TANK

#1 CONT'D The second underdeck transverse angle from the bow stem is wasted and called out for replacement of its entire length. The material was originally 4" x 3" x 3/8" angle and is approx 8' long. The surrounding structure will not allow installation in one or two pieces and will require a 3-piece installation. The location in the overhead will require a scaffolding structure to be constructed as a work platform and will also serve as access to the deck connection of the sounding pipe for replacement. The sounding tube is 1-1/2" pipe and approx. 16' long. Fabricate and install new sounding pipe with striker plate and support brackets, assuming the deck box is re-usable as-is and the new pipe will weld to the housing under deck. Pump out water in bottom of space, clean out loose rust scale and debris, cleanup from repairs. Application of (1) coat of AC epoxy is included for all new steel.

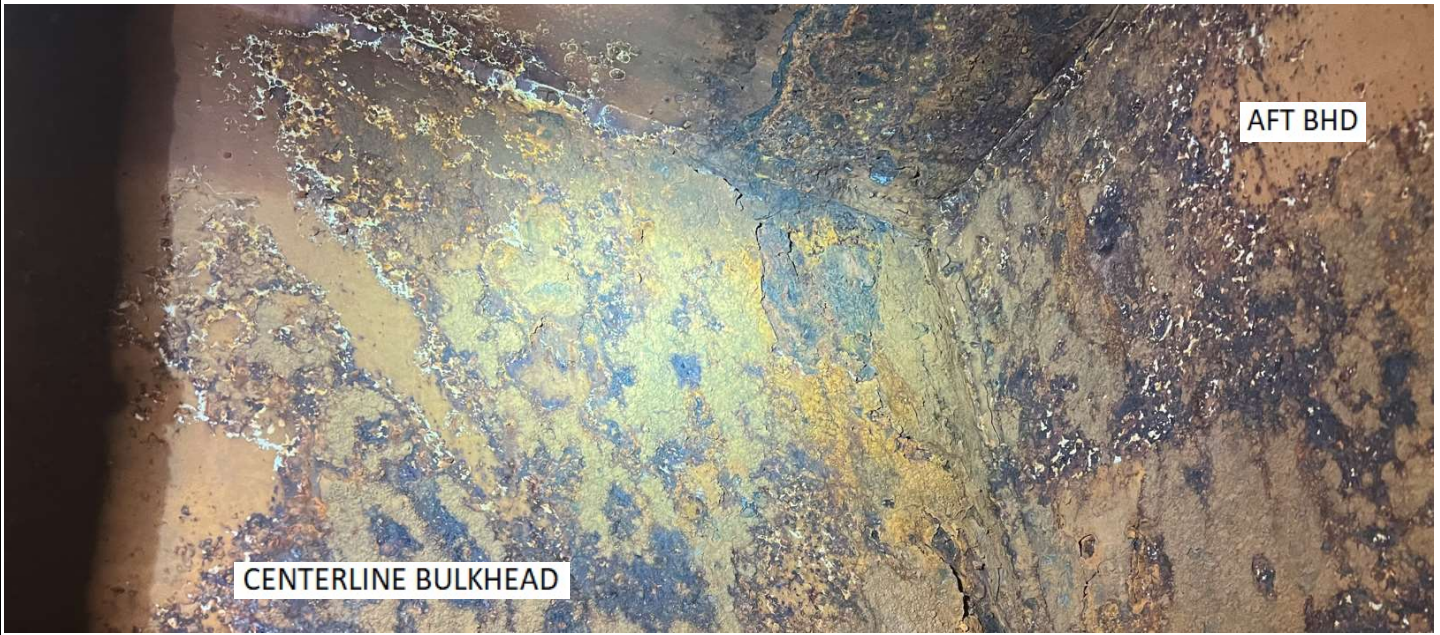
2. #2 BALLAST TANKS PORT / STBD

Sounding tubes and brackets in both port and stbd tanks are wasted and need replacement. Scaffold for access and same assumptions for re-use of the deck boxes apply. Tubes are 1-1/2" pipe and approx 16' long. The centerline bulkhead seems quite thin and ABS is calling for it to be gauged. Price includes gauging services and report of findings with repair recommendation. Application of (1) coat of AC epoxy is included for all new steel.

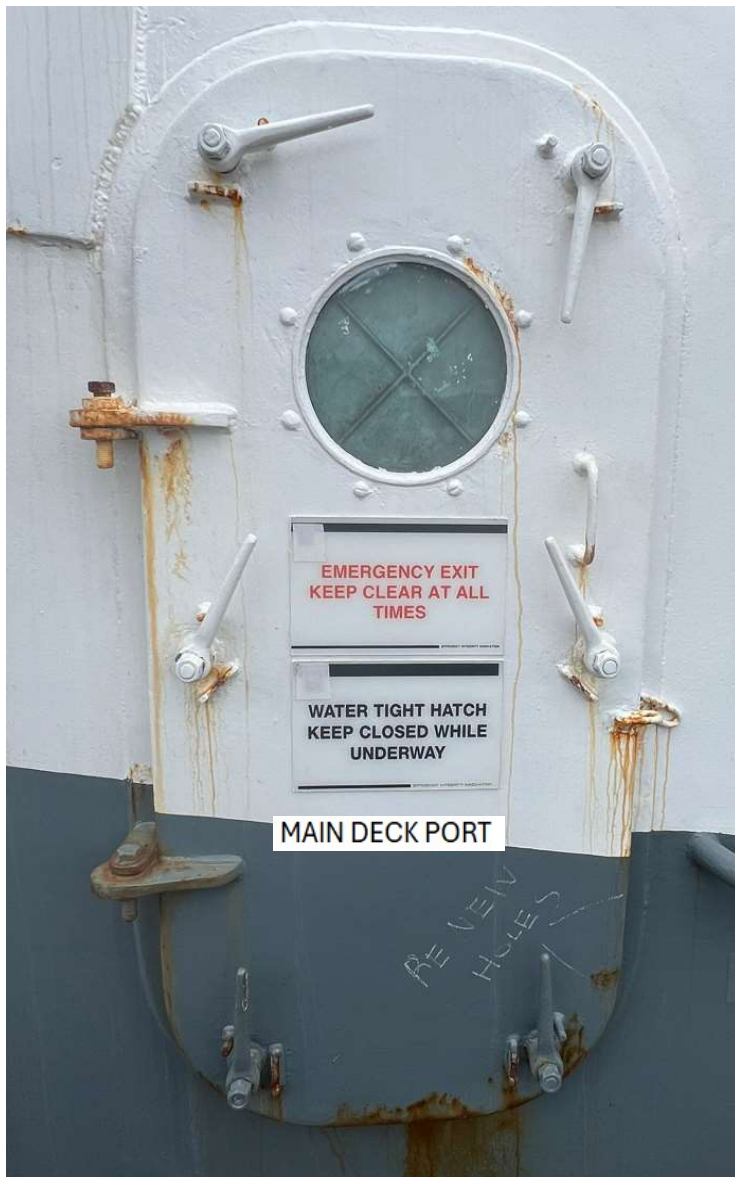
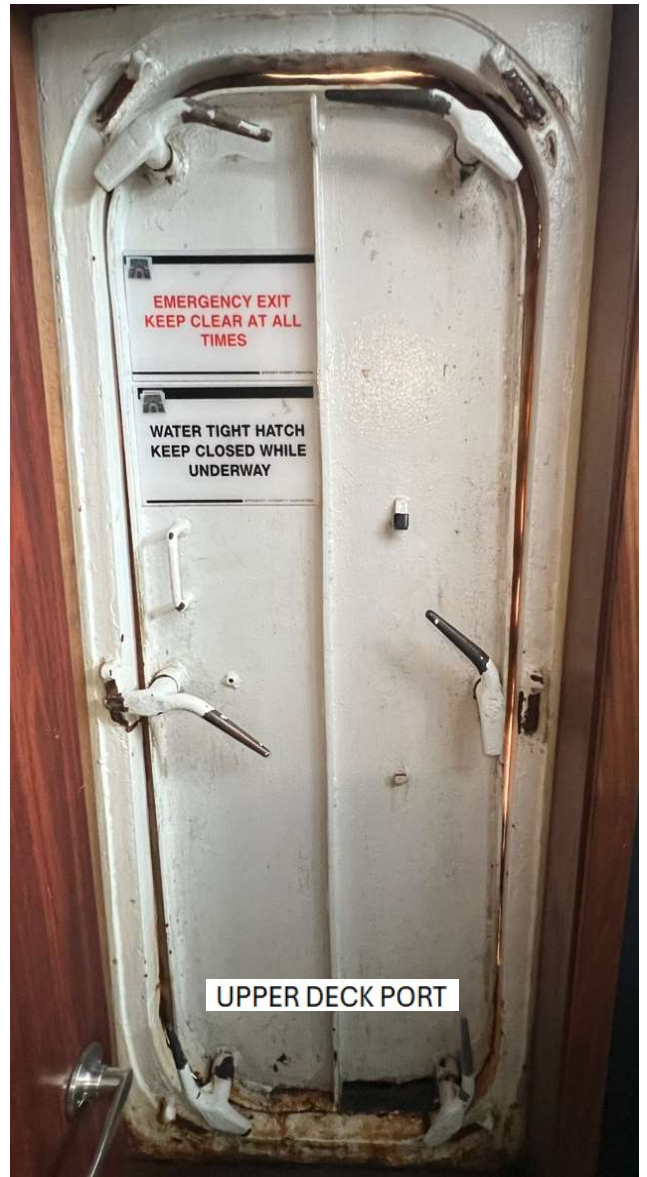
3. WATERTIGHT DOORS

ABS has called out for the port side watertight door at the main deck level to be replaced due to holes in the aft lower door coaming. ABS also noted that all doors are missing nuts from the hinge hardware. All watertight doors are severely misaligned and appear to have been repaired previously. With the overall condition of all the doors being very poor, and repair cost that will likely exceed the cost of a new door, this item has been priced appropriately to replace all (4) doors entirely. Cost for this item includes R&R of local interior joiner panels and coating of affected areas typical to original.

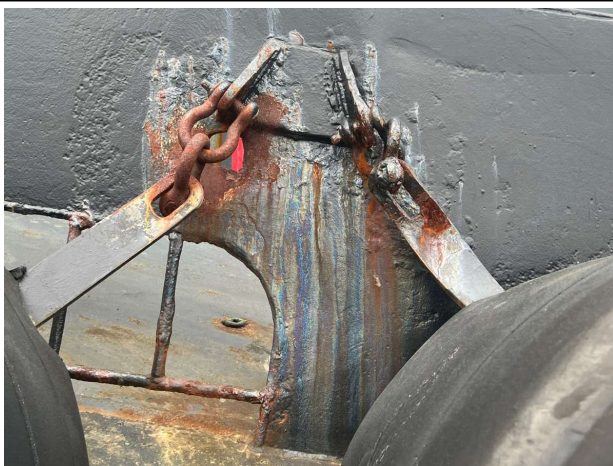
Port side Location #1: 22" x 30" x 3/8" plate

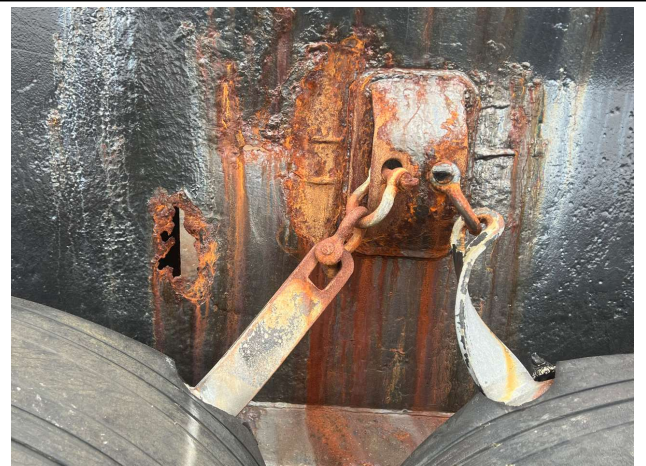
Port side Location #2: 48" x 30" x 3/8" plate

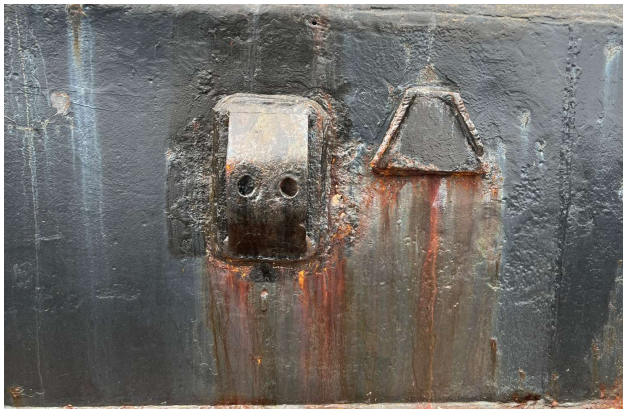
Port side Location #3: 32" x 30" x 3/8" plate

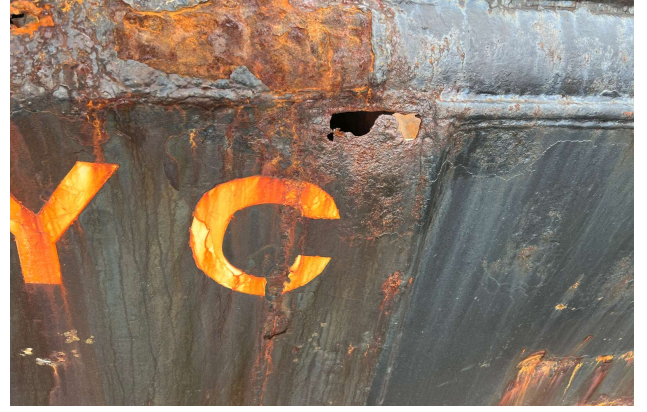
Stbd Location #1: 18" x 30" x 3/8" plate

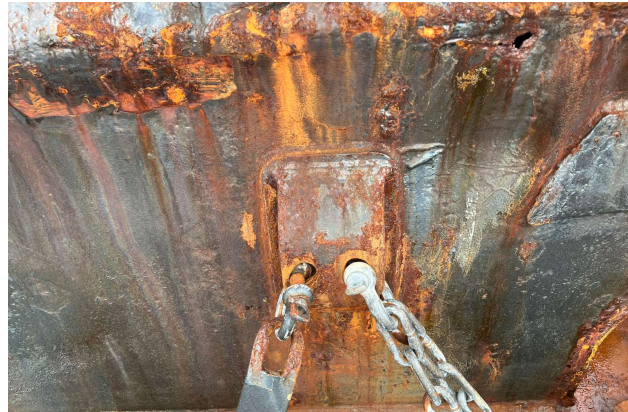
Stbd Location #2: 30" x 30" x 3/8" plate

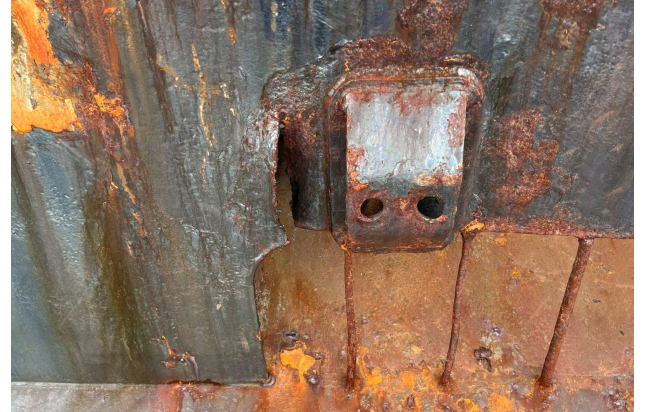
stbd Location #3: 18" x 30" x 3/8" plate

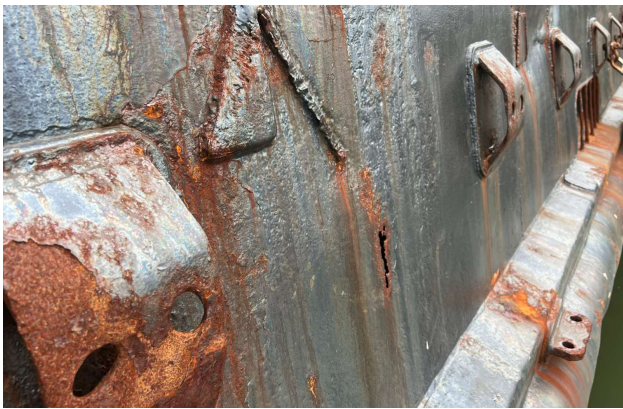
Stbd Location #4: 18" x 30" x 3/8" plate

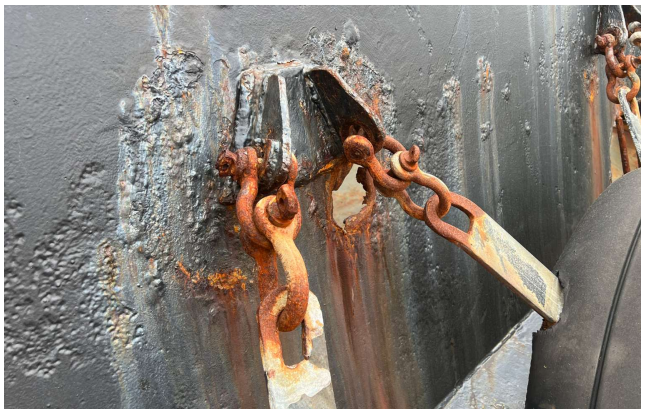
Stbd Location #5: 18" x 30" x 3/8" plate

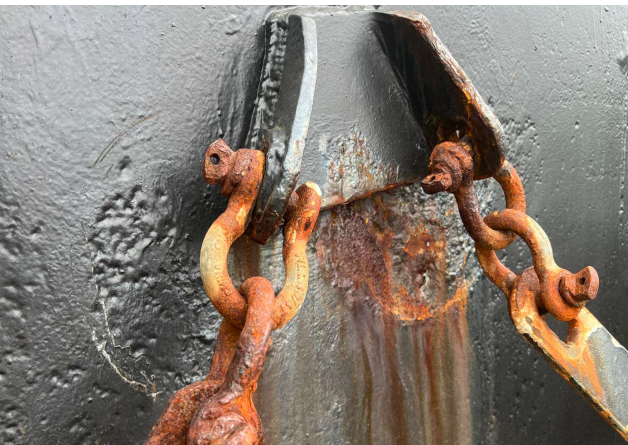
Stbd Location #6: 18" x 30" x 3/8" plate

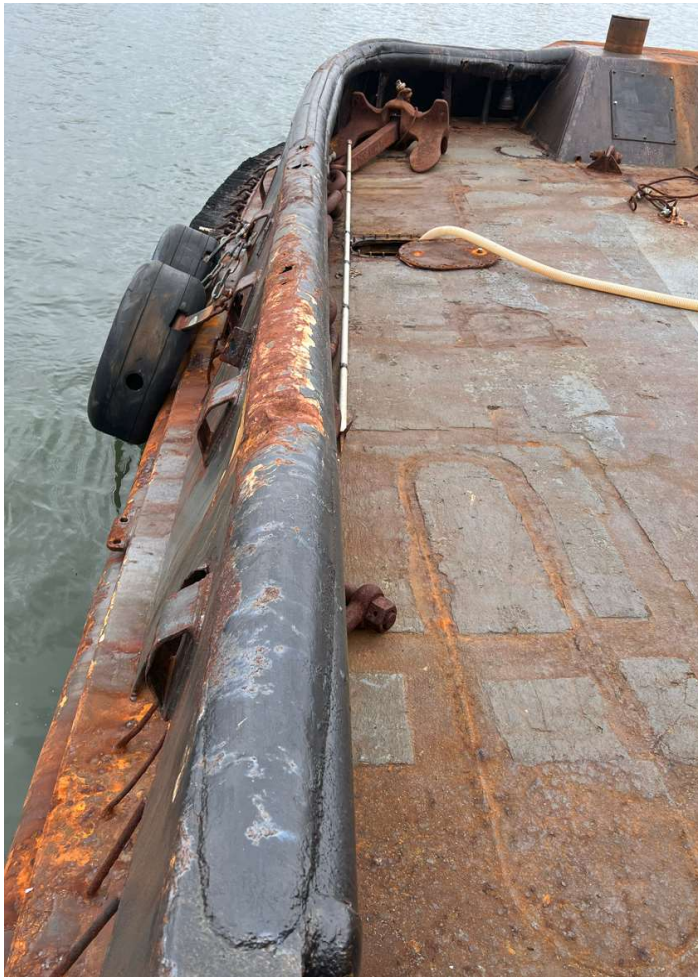
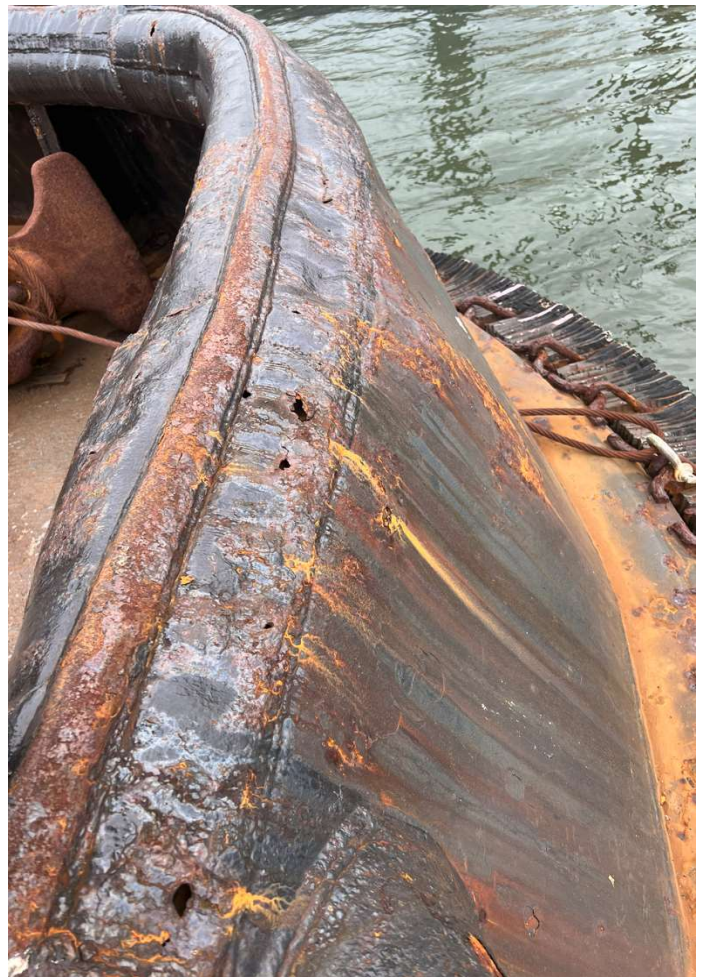
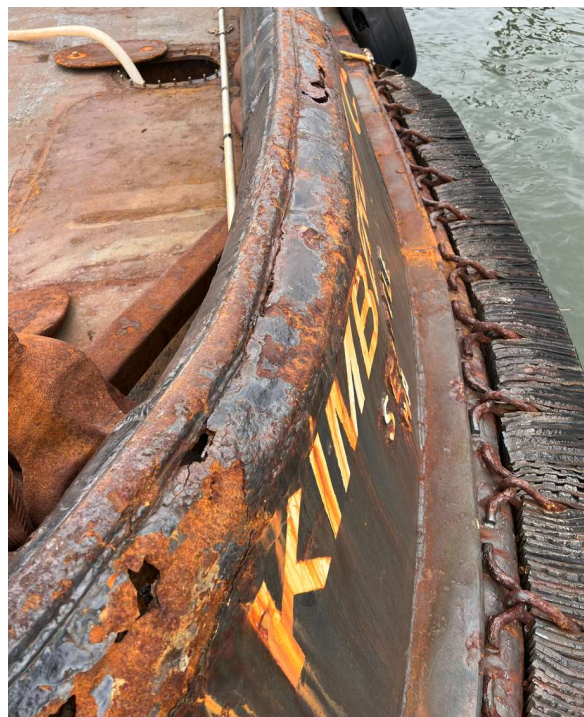
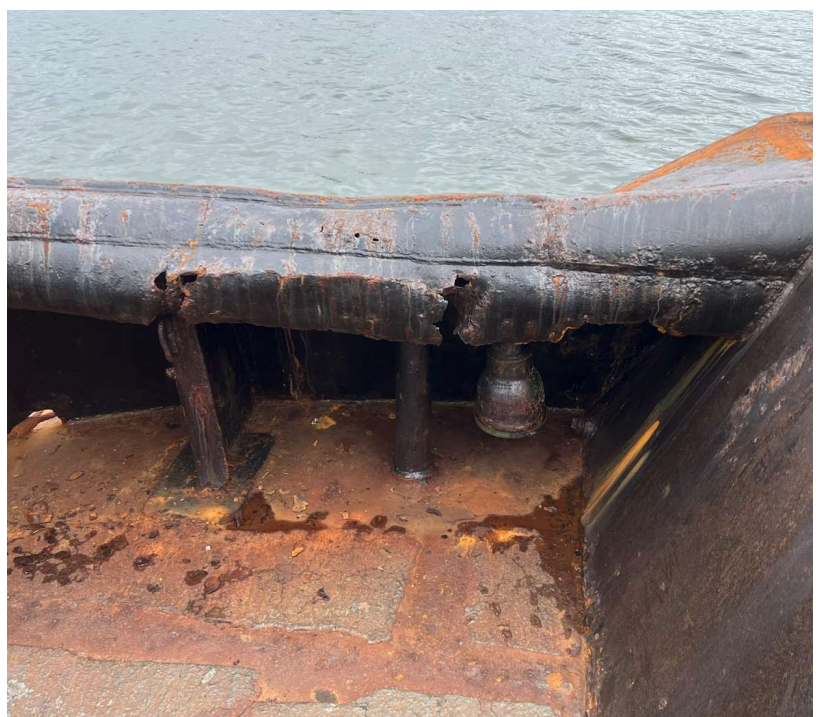
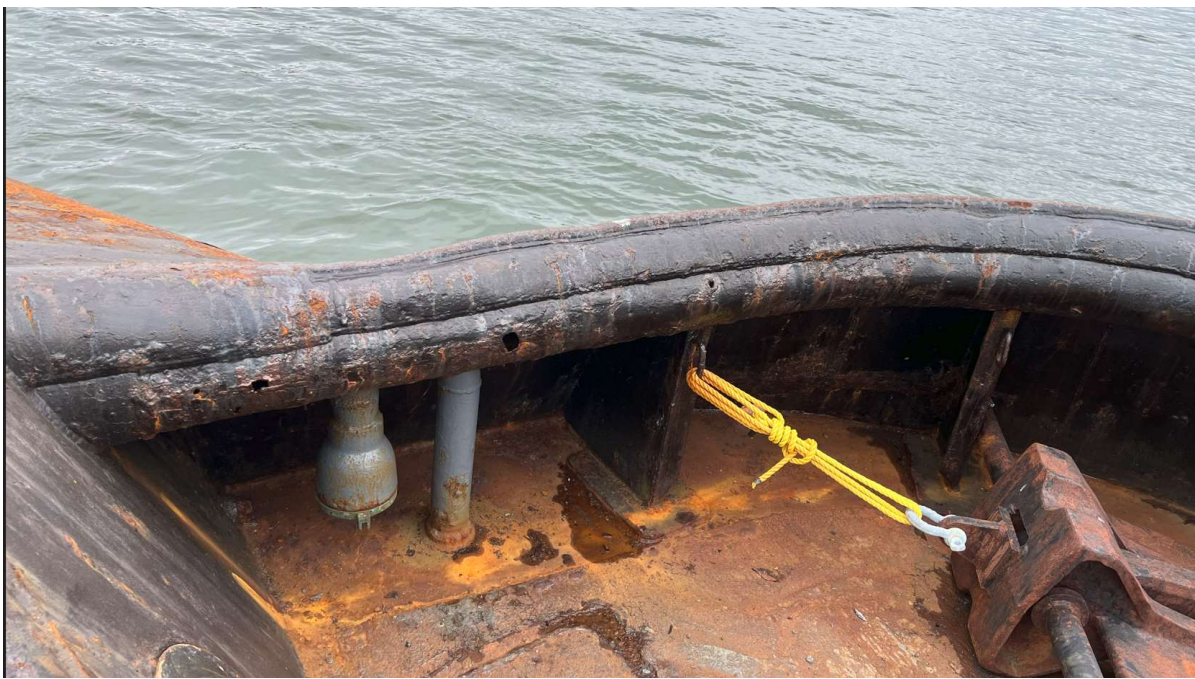
5. BULWARK CAP RAIL**ESTIMATED COST:****\$43,626**

The bulwark "cap rail" was called out by ABS as holed and wasted aft of the house port & stbd to centerline. The wasted steel ABS is referring to is actually a pipe fairing to soften the bulwark cap for the tow gear. Pricing for this item is for removal of this pipe and assumes that the existing 1" thick cap rail underneath is re-usable with mechanical preparation and coating. Local renewal of fairing at the tow pin table port / stbd only is included to soften this transition in heights.

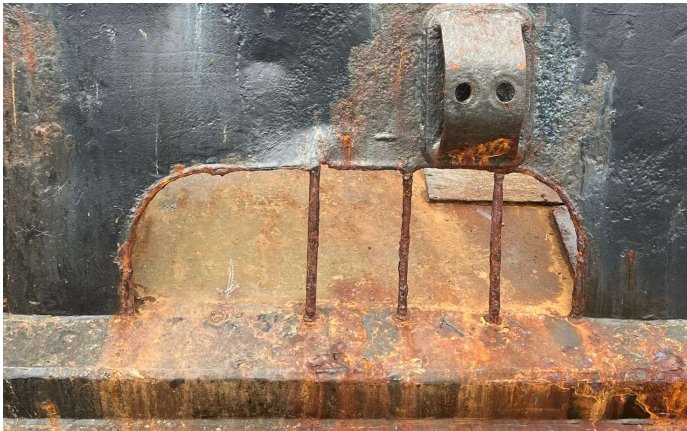
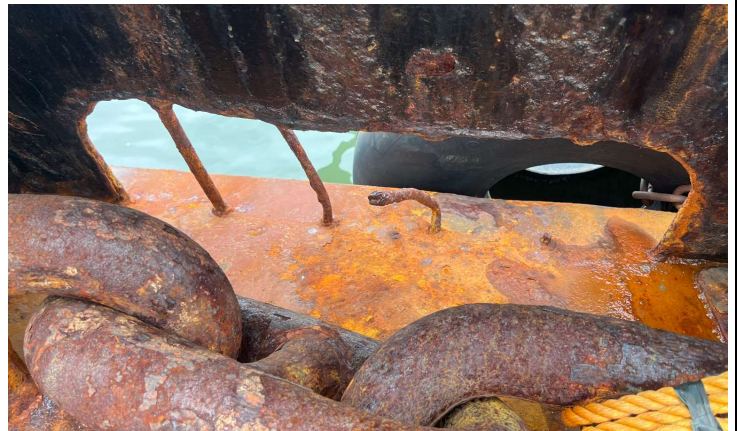
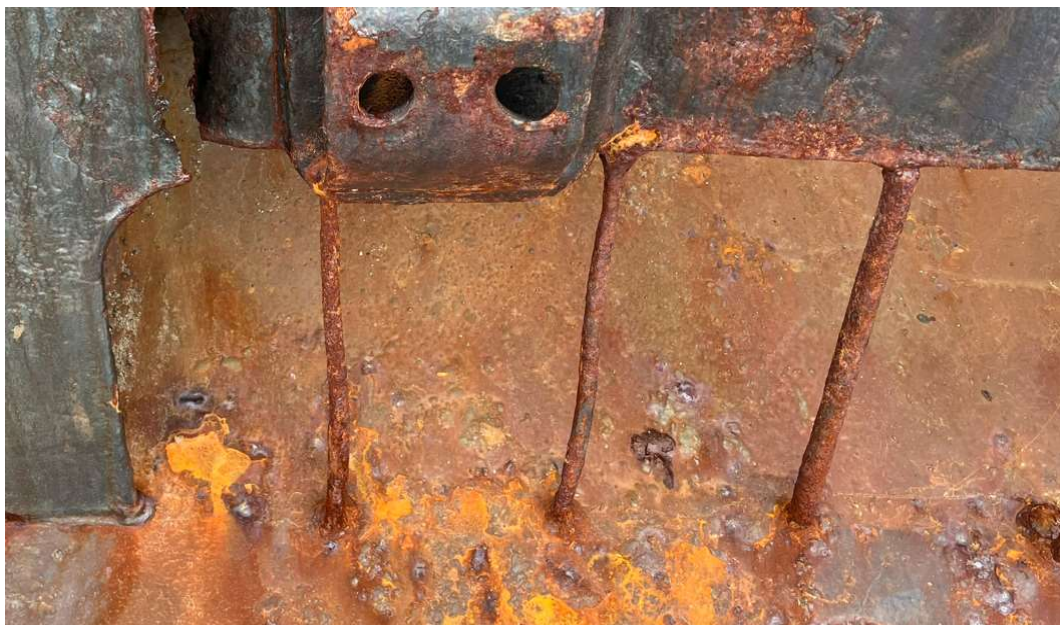
6. FREEING PORT OPENINGS

ABS noted that roundbar guards at freeing ports were either missing or broken and need to be replaced. Pricing for this item is for replacement of the ones noted below and assumes that the adjacent spaces are already gas free.

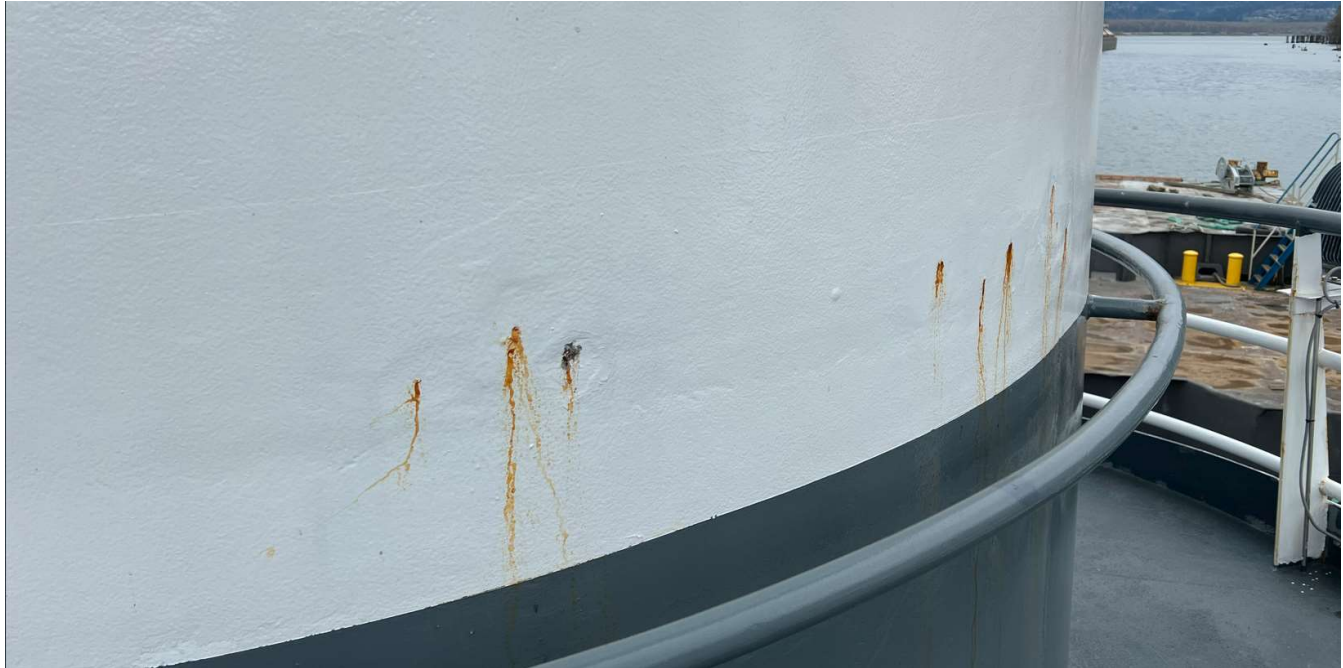
8. FWD DECKHOUSE PLATING AT BRIDGE DECK	ESTIMATED COST:	\$810
---	-----------------	-------

ABS noted as series of holes or thin spots at the fwd side of the house at the bridge deck level. The area was called out for gauging to determine the wastage present. Pricing for this item is for gauging services only. A repair plan will be developed once the scope of work is known. **** THIS ITEM HAS A SIGNIFICANT POTENTIAL FOR GROWTH WORK BASED ON NOTED DETERIORATION AND THE SENSITIVE LOCATION THAT HOUSES ELECTRONICS BELOW THE PILOTHOUSE. INTERFERENCES TO MAJOR REPAIRS ARE A MAJOR CONTRIBUTING FACTOR TO TOTAL COST.**

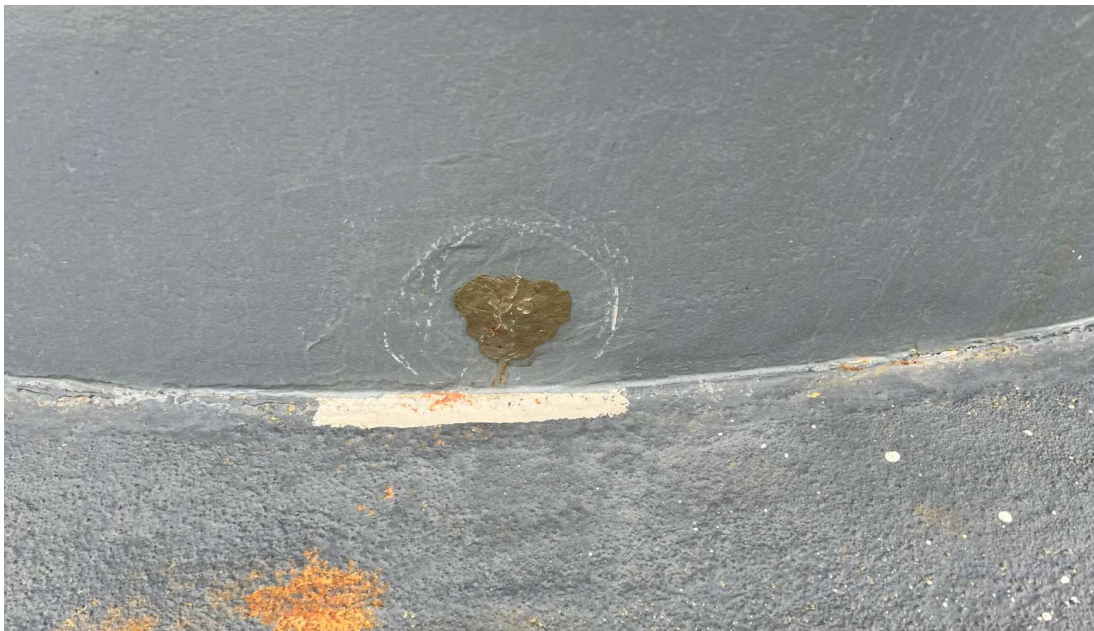
9. FWD DECKHOUSE PLATING AT UPPER DECK	ESTIMATED COST:	\$810
--	-----------------	-------

ABS called out a soft patch (splashzone) on the fwd side of the house at the upper deck level and the surrounding area is suspect for deterioration. Area to be gauged to determine the wastage present. Pricing for this item is for gauging services only. A repair plan will be developed after the scope of work is known. **** THIS ITEM HAS A SIGNIFICANT POTENTIAL FOR GROWTH WORK BASED ON NOTED DETERIORATION AND THE SENSITIVE LOCATION IWO INTERIOR JOINER WORK. INTERFERENCES TO THE STEEL REPAIRS CAN BE A MAJOR CONTRIBUTING FACTOR TO OVERALL COST.**

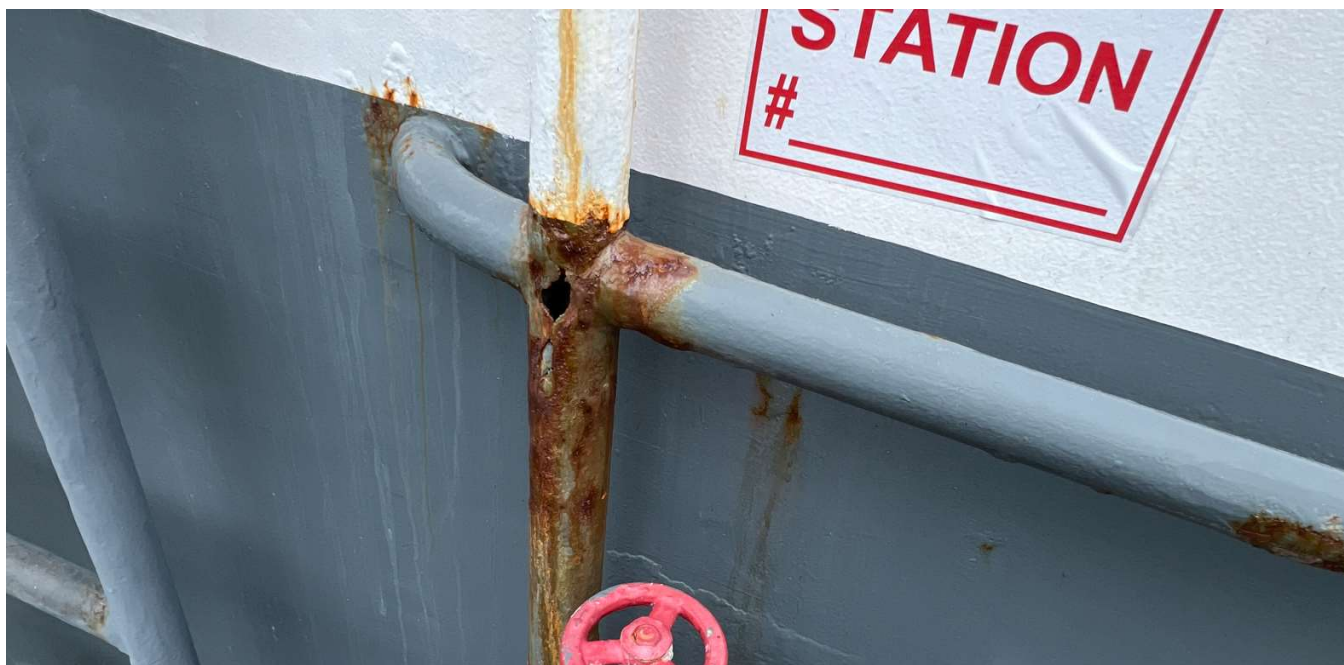
10. PORT SIDE SEA CHEST VENT**ESTIMATED COST:****\$3,594**

ABS called out the port side sea chest vent to be replaced. Pricing for this assumes the existing deck sleeve will be retained and the 1-1/2" pipe and 180 degree return will be replaced completely above the main deck level. Pricing assumes the adjacent handrail can be re-used with only local repair at connection to vent required (no impact to house)

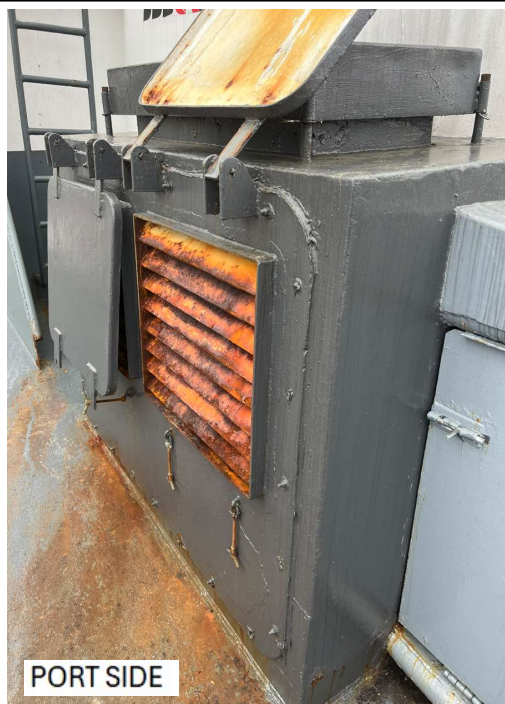
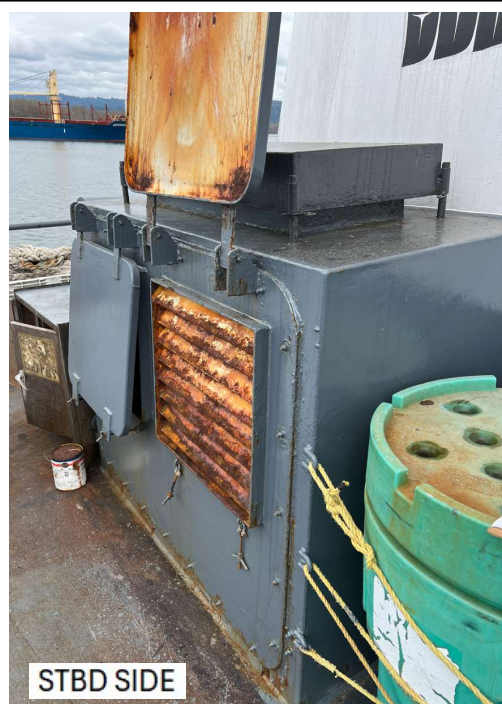
**11. PORT & STBD VENTILATION PLENUMS****ESTIMATED COST:****\$8,502**

ABS called out for the plenums to be opened and internally inspected & gauged port and stbd sides. The decks beneath the plenums on both sides were called out to be gauged also. Both plenums appear to be significantly deteriorated with packed rust visible on the exterior and interior closures in the fiddley and existing splashzone patches at the upper deck level. Pricing is only for the R&R of the large exterior closure plates show below and inspection / gauging services. A repair plan will be developed after the scope of work is known. Incidental hardware renewal and new gasket materials are included in pricing **** THIS ITEM HAS A SIGNIFICANT POTENTIAL FOR GROWTH WORK BASED ON EVIDENCE OF PREVIOUS REPAIRS AND NOTED DETERIORATION. INTERFERENCES TO REPAIRS ARE ALSO A MAJOR CONTRIBUTING FACTOR TO TOTAL COST.**

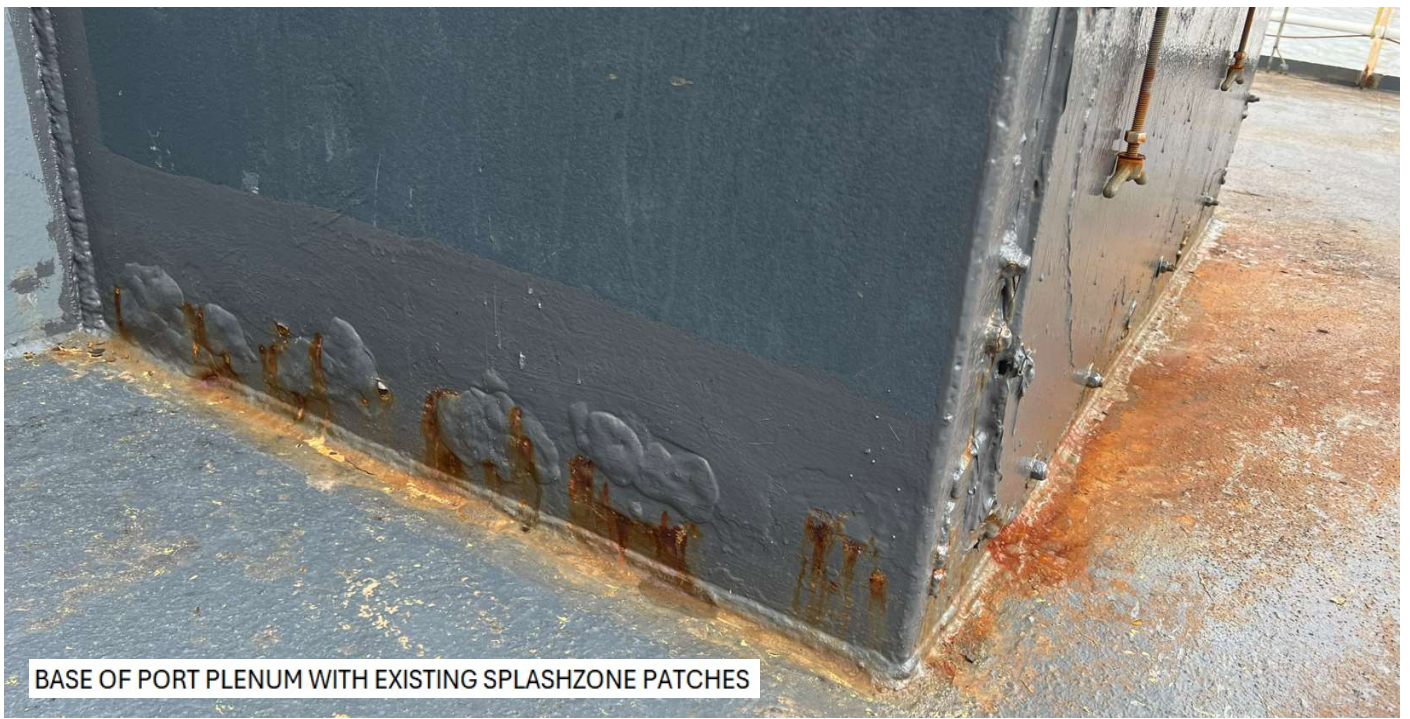
BASE OF PORT PLENUM WITH EXISTING SPLASHZONE PATCHES

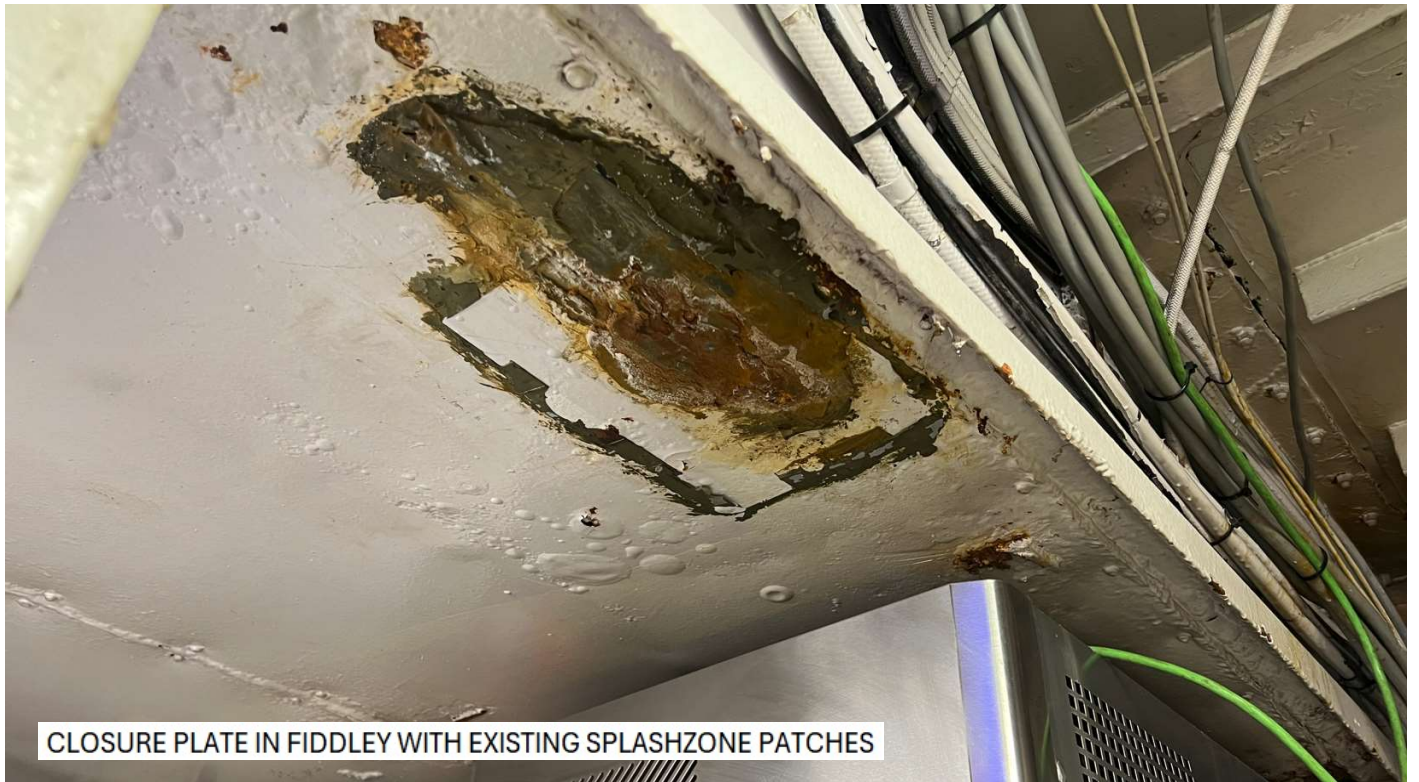
CLOSURE PLATE IN FIDDLEY WITH EXISTING SPLASHZONE PATCHES

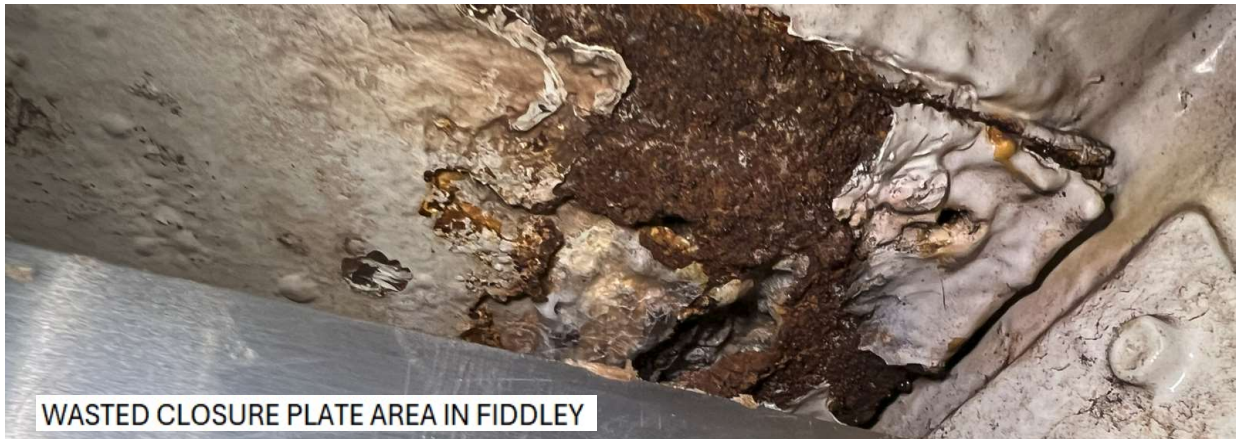
WASTED CLOSURE PLATE AREA IN FIDDLEY

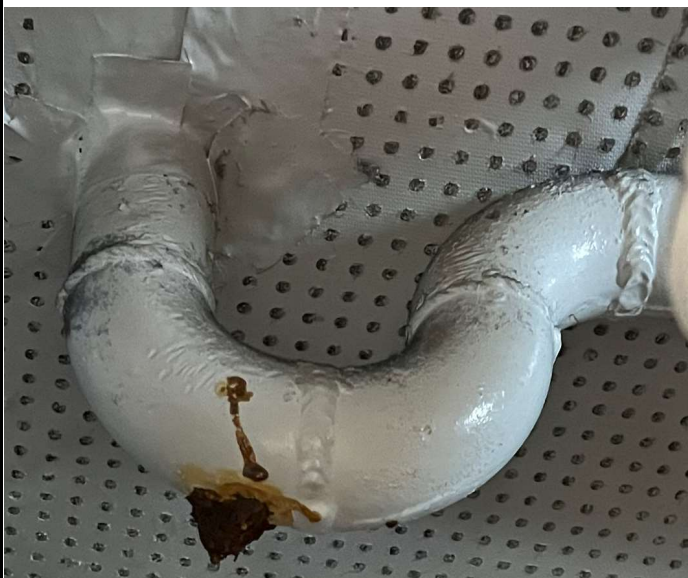
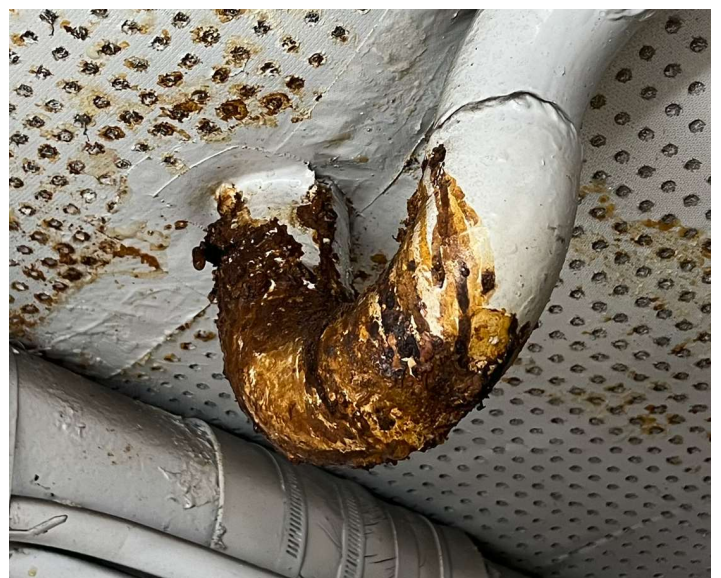
12. DECK DRAINS IN ENGINE ROOM

ABS called out (1) deck drain port side and (1) deck drain stbd side in the overhead of the engine room. These deck drains have obvious signs of being completely wasted and need to be cropped out and renewed. Price for this item assumes that the repairs can be made within the engine room without affect to interior spaces of the deckhouse above. Scaffold access, local insulation R&R and coating of completed repairs is included in the price for this item.

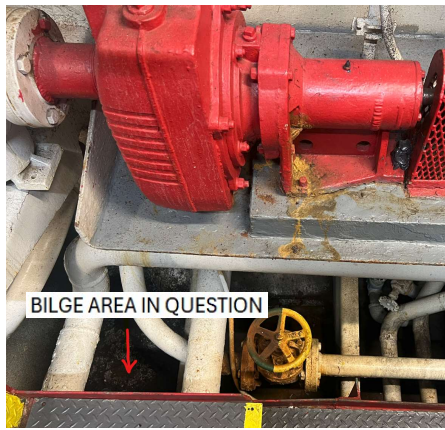
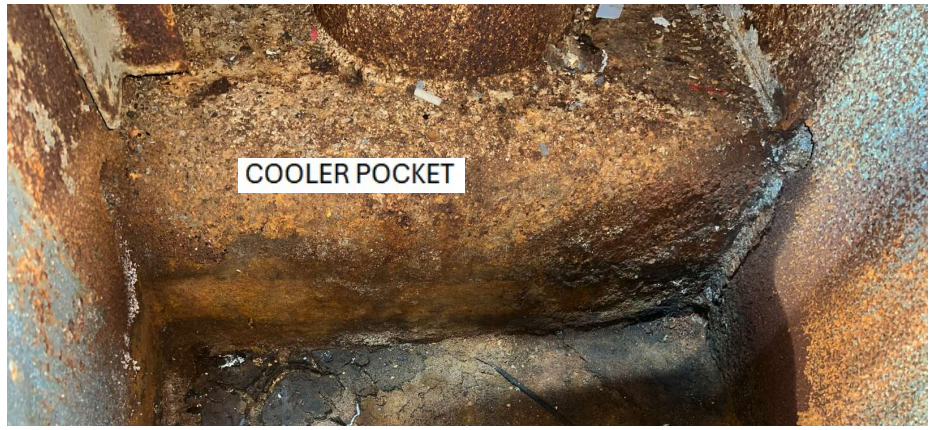
13. HULL IWO COOLER POCKET UNDER FIRE PUMP

ABS called out a suspect area of the hull IWO the cooler pocket under the fire pump on the stbd side of the engine room. It appears as though the fire pump has been leaking and the deterioration noted may be superficial but gauging has been specified to determine condition. Pricing for this item is for R&R of local floorplates for access and gauging services only. A repair plan will be developed after the scope of work is known.

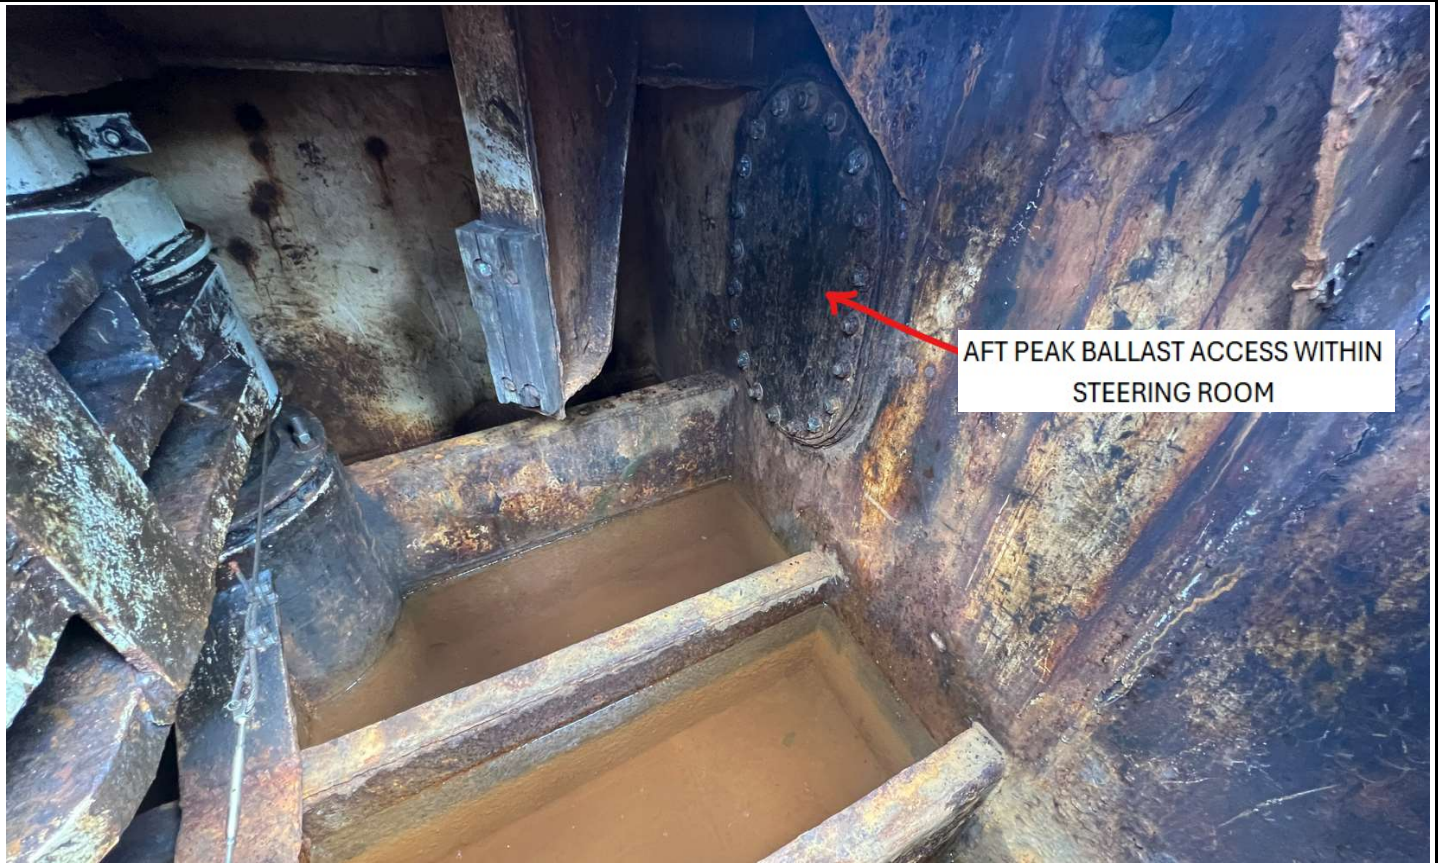
AFT PEAK BALLAST ACCESS WITHIN STEERING ROOM

- Space #7: STEERING ROOM-APPROX 300 GAL STANDING WATER**
Standing water throughout the space, contaminated with residual grease / oil from steering components
Wash and pump out space
Assumptions: Pump out standing water for JTM to access and evaluate condition prior to washing.
JTM to wrap up / protect components as required to protect from water intrusion before washing starts.
