KIMBERLY C ABS REPAIR ESTIMATE

DATE : 6/18/24

This repair estimate is for items that were called out on the ABS surveyor's report on 3/1/2024. Assumptions have been made for some items based on best marine practices and experience with previous repairs similar to these items. Items requiring gauging of steel thickness will need to be quoted once the gauging and recommended repair plan has been received.

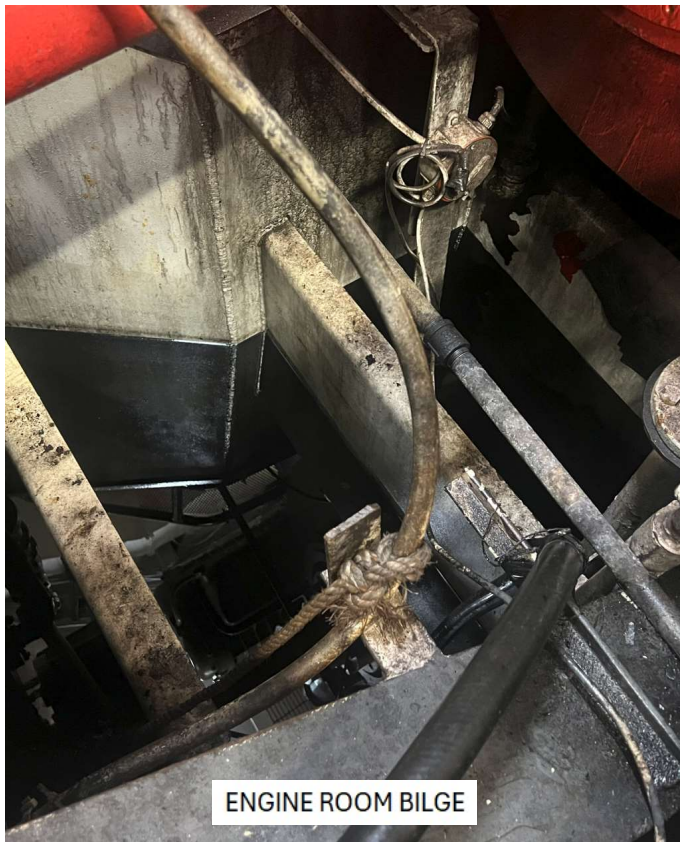
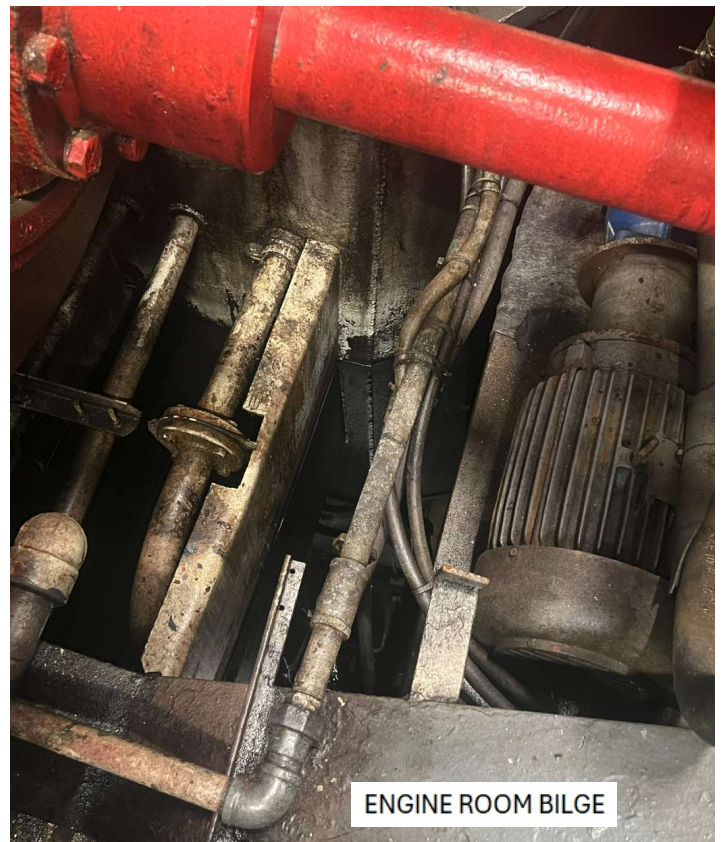
ENGINE ROOM BILGE

- Space #1: ENGINE ROOM BILGES -APPROX 800 SQ FT / AVERAGE 5' DEEP**
Condition: poor, approx. 1,000 gallons oil / water in bilges and solids / debris present
Access: Difficult around piping systems in bilge
Assumptions: JTM will remove and replace deck plates, furthest distance onboard to pump truck=100'
