# SURVEY SUMMARY REPORT

Vessel: Kimberly C

Type of Survey : Hull & Machinery

Date of Survey : 5/27/2023

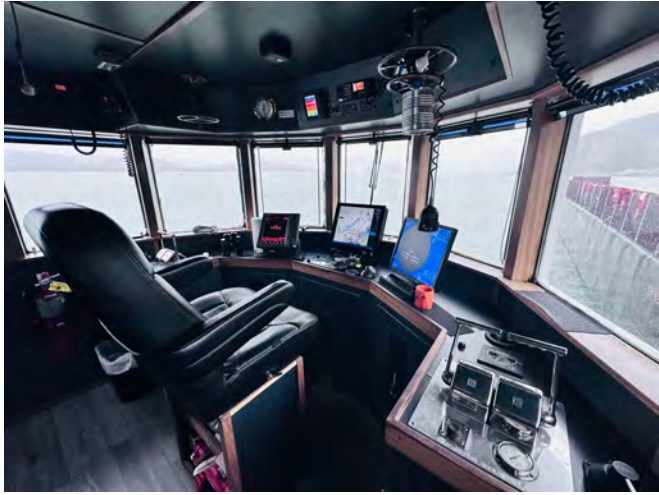
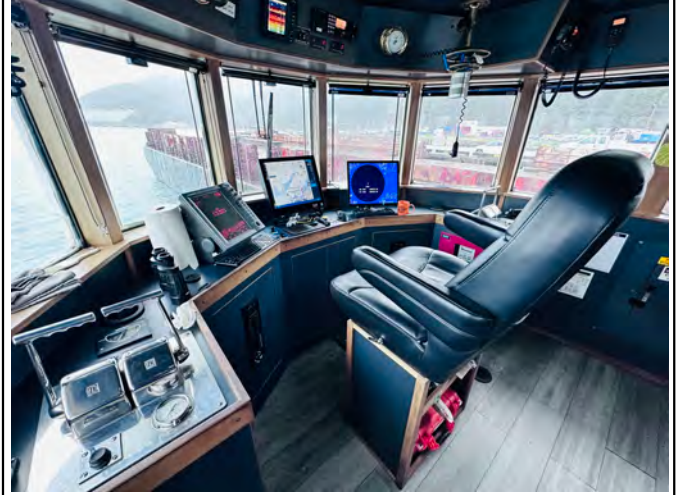
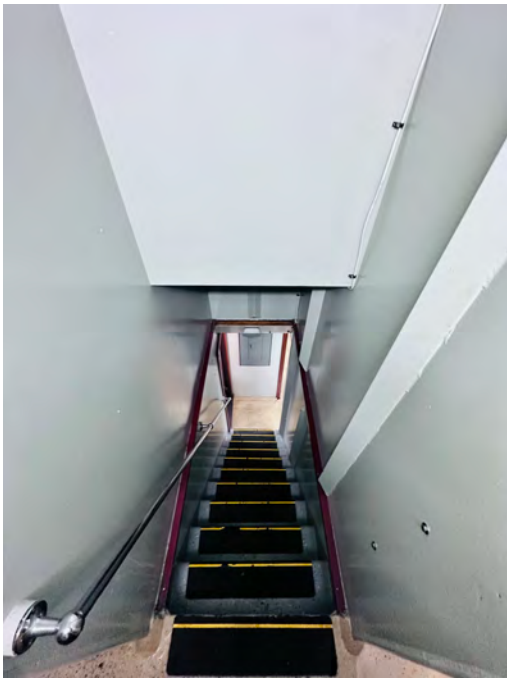
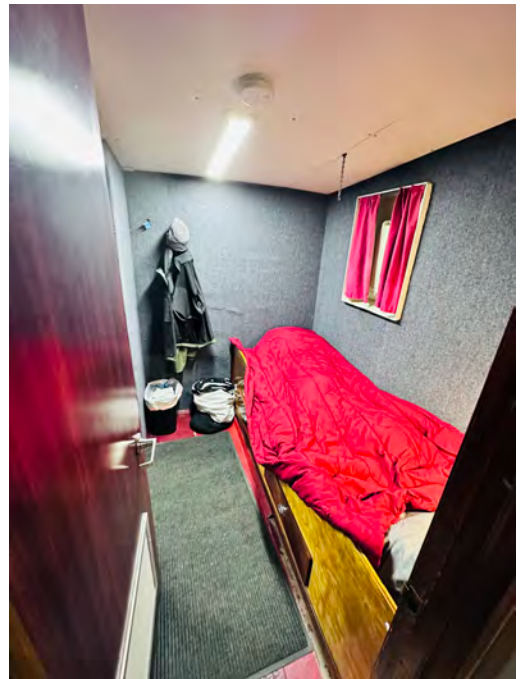
# Bridge and Cabin Photos

The Bridge was inspected and found to be in very good condition. The steel structure of the house was inspected and found to be in good condition. Very little surface rust was found. Metal appears to be .225" plate steel that is welded to the lower structure. Electronics were tested and found serviceable and operational. The condition of the interior was in very good condition. Floors, ceiling, walls, upholstery, dash and counters were all found in clean well-maintained condition. The glass wind shields, and window frames were found leak free and in good, maintained condition. A top the pilot house the main mast was inspected and found in good condition. The antennas, radar, navigational lights, flood lights and navigational instruments were all found in good condition and serviceable. The steel mast was found in good condition with some areas of rust and corrosion starting but not nothing uncommon. Aft of the mast is the vessels air handlers for the accommodation spaces. The air handlers were all found in good serviceable condition.
